DOE/NASA/20320-30
NASA TM-81719

Test Evaluation of a Laminated Wood Wind Turbine Blade Concept

James R. Faddoul
National Aeronautics and Space Administration
Lewis Research Center

May 1981

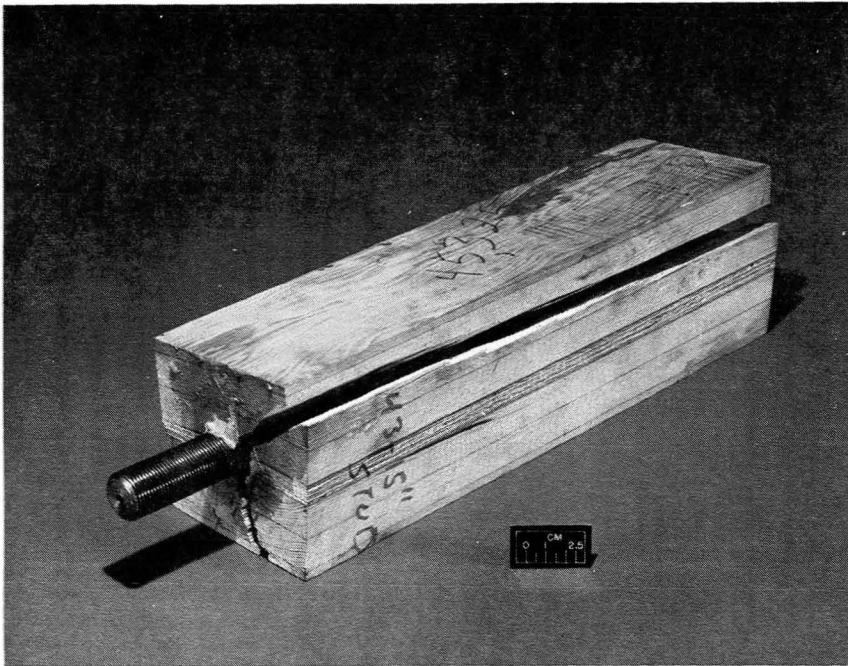
First, because the stud transfers load to the wood through shear in the epoxy resin, high shear stresses develop at the point of entry of the stud into the wood block. These shear stresses cause significant cross grain tensile stresses to develop at the end of the wood block. Since the cross-grain tensile capacity of the wood is less than 500 lb/in.², the result is a splitting failure of the wood with a premature pull out of the stud (see Fig. 6). It was found that bonding a thin layer of birch plywood to the end of the specimens would alleviate this problem. Plates clamped to the top of the specimen and fiberglass wrapping of the top were also tried but with less success. The effect of the birch ply can be seen in Figure 7 where comparative tensile load capacities are presented. As a result, birch ply was added to all subsequent stud test specimens and was also used to cap the end of the 20 ft blade test section.

Figure 6. - Specimen without birch ply - cross grain failure.

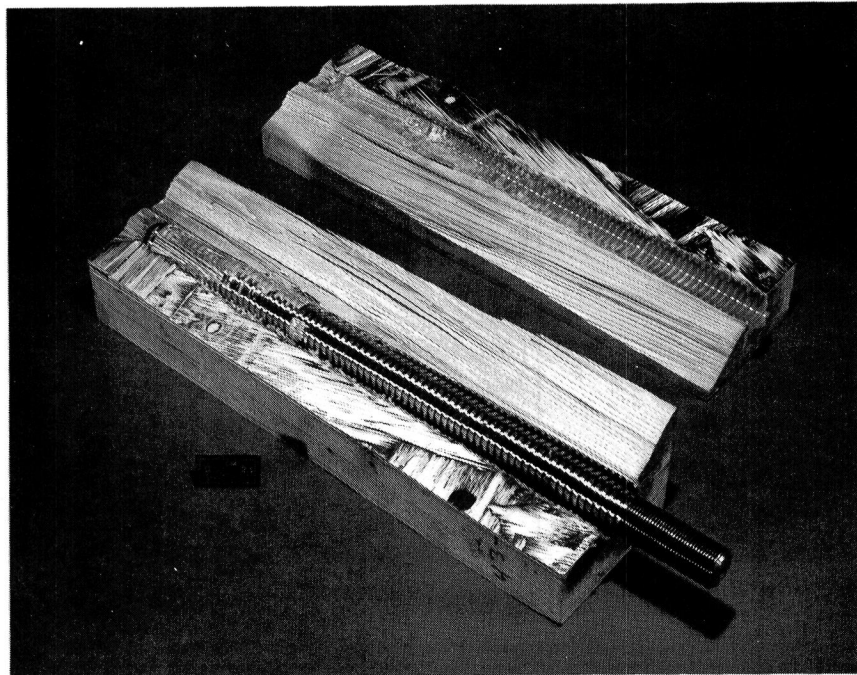
- (7) With reference to the tensile ultimate capability as shown in Figure 7, fir block with plywood core specimens are inferior to fir block or laminated fir in load carrying capacity. The specimens have a tendency to split within the plywood, as shown in Figure 12, resulting in a premature failure of the specimen. Because of this problem, the blade design was modified to eliminate the plywood shear web in the area of the stud bolt-circle blocking.

Figure 12. - Failure of plywood layer.

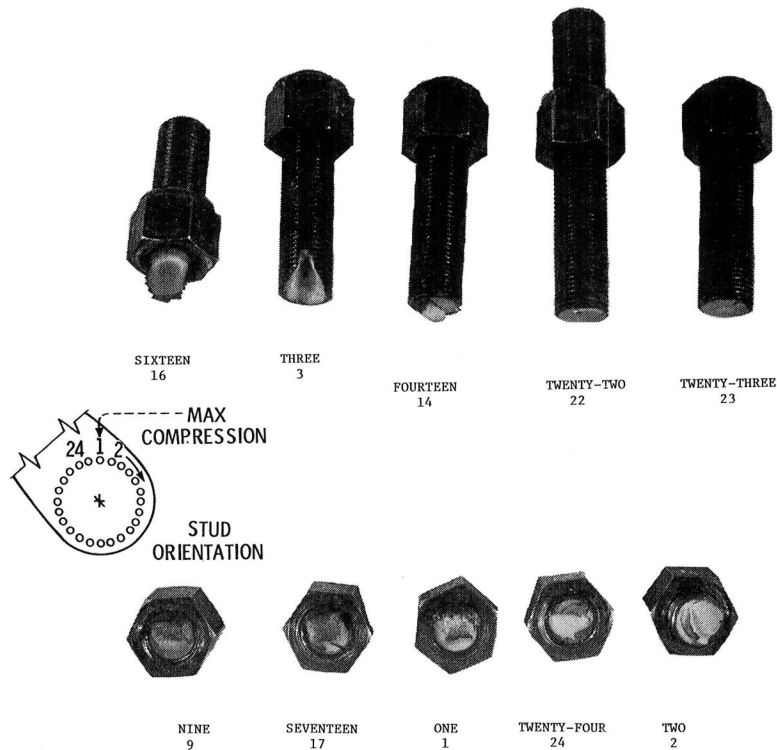
4.2.1 Problem Definition and Resolution. - After running a load/deflection/strain test, the fatigue testing was started by applying a cyclic force between 500 and 4000 lb at the free end of the blade. A cyclic frequency of 4 Hz was used throughout the testing (except for some limited attempts at 6 and 8 Hz operations). This load was equivalent to the rated wind condition on an actual blade. After 370,000 cycles it was found that 10 of the studs had failed in the 5/8 in. diameter threaded length outside of the wood. All but 4 of the failed bolts were on the compression side of the bolt circle and subsequent examination (Fig. 30) indicated that failure of the studs was due to bending and not tensile stresses. Visual observations of the framework during testing corroborated this analysis since the 2 in. thick steel plate could be seen to deflect significantly under load. There was no evidence of any damage to the wood portion of the test specimen.

Figure 30. - Photograph of broken bolts.

Rather than abandon the test, the specimen was sent back to the contractor, Gougeon Bros., Inc., for replacement of the studs. This became an ordeal as it was quickly learned that removal was not easy. A number of staples had been used in the construction of this blade section (a practice which is no longer used) and the staples made the use of a deep hole saw difficult. An attempt was then made to simply unscrew the studs from the epoxy. This resulted in breaking the stud. The unscrewing technique was then tried in combination with application of a high amperage current to heat the stud and soften the epoxy. This was equally unsuccessful. Finally, the hole saw technique was made to work by "brute force" with the result that a rather large and uneven hole was left in the blade as each stud was removed. These holes were subsequently smoothed and tapered by a large boring cutter and were then filled by matching tapered wood plugs made from laminated fir. When all studs had been removed and the holes filled, the root of the test section was redrilled and fitted with 24 new studs having a slightly modified configuration (Fig. 31) featuring a 3/4 in. diameter threaded shank rather than the

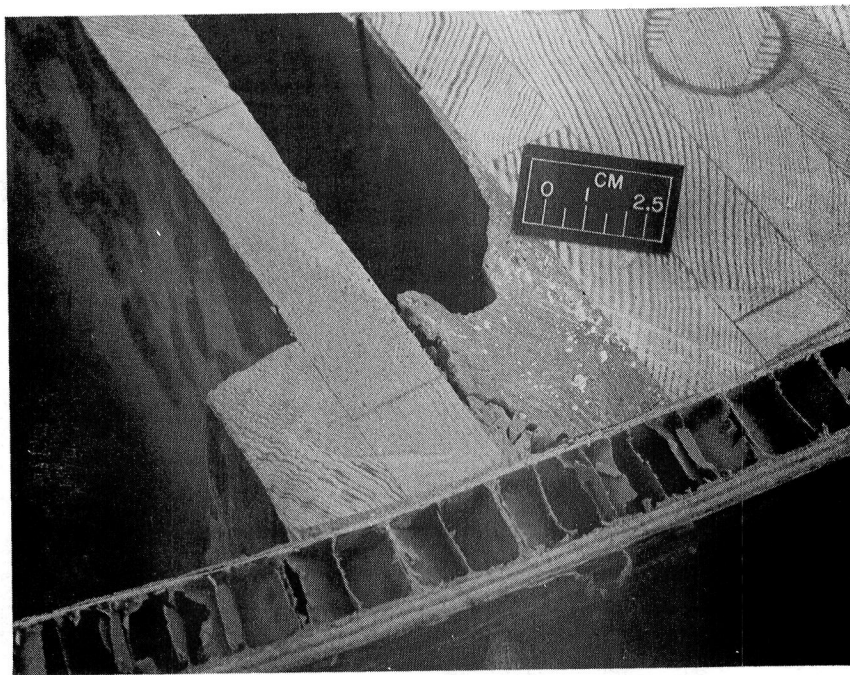
Figure 41. - Excess epoxy between root end blocking and diagonal rib.

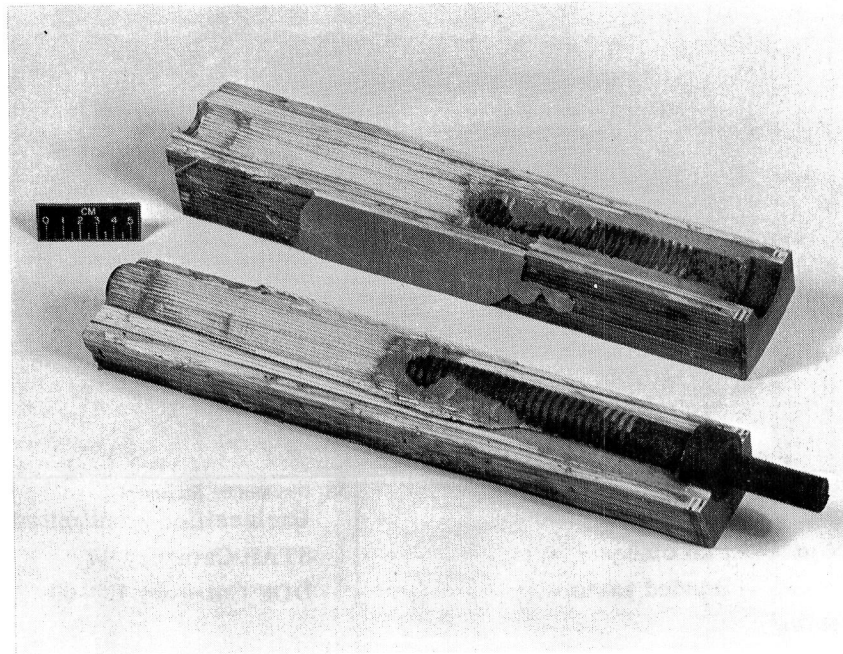
Several studs were removed from the blade and an attempt was made to examine the cast epoxy area. By slicing through wood and epoxy on either side of the stud and then prying the two halves apart, it was possible to visually evaluate the result of the testing on the stud bond. In general, the studs were still well bonded. In local areas, the epoxy was cleanly separated from the stud and in some areas there was evidence of fatigue cracks in the epoxy. None of the damage was as severe as that seen in the individual stud tests discussed in Sec-

tion III. It is therefore believed that the stud-to-wood bond was not close to fatigue failure. A picture of one of the studs with the wood and epoxy broken away is shown in Figure 43.

Figure 43. - Stud removed from root end of 20 foot section after test - wood and epoxy cut and pryed open for examination.
